Re: Monthly Report Summary #17 for the South Orange County Reliability Enhancement (SOCRE) Project

South Orange County Reliability Enhancement Project CPUC Site Inspection Form

Project:	South Orange County Reliability Enhancement (SOCRE) Project	Date:	March 14, 2019
Project Proponent:	San Diego Gas & Electric (SDG&E)	Report #:	VS026
Lead Agency:	California Public Utilities Commission (CPUC)	Monitor(s):	CPUC/Ecology and Environment (E & E) Compliance Monitor
CPUC PM:	Andrew Barnsdale, Energy Division	AM/PM Weather:	Sunny, cool, and calm
CPUC CM (E & E):	Joe Donaldson	Start/End Time:	0800 to 0930
Project NTP(s):	NTP-1, NTP-2, NTP-2 Addendum 1, NTP-3, and NTP-4

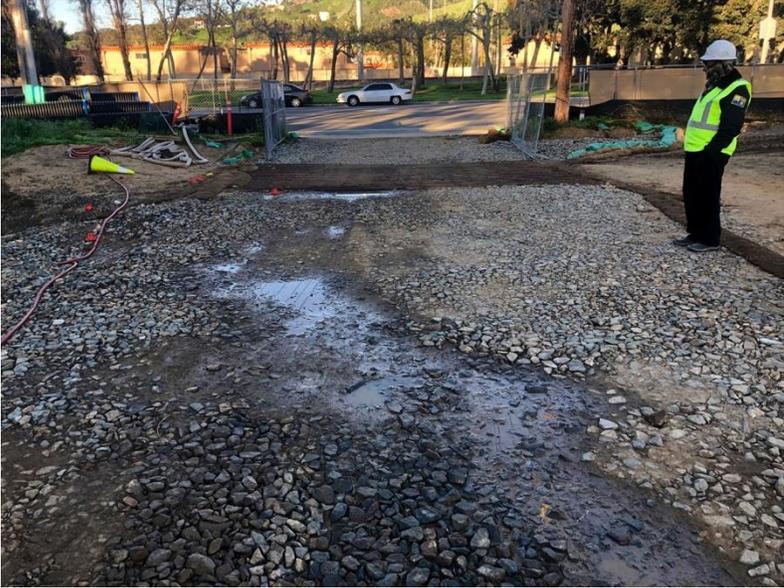
I noted that the rock and rumble plate at the main entrance to the San Juan Capistrano Substation site required maintenance (Photo 1). I spoke to the SDG&E Lead Environmental Coordinator about this maintenance issue. I was told the contractor would be notified. Photo 2 shows an overview of the western portion of the San Juan Capistrano Substation site.

Photo 1 – BMPs at the main entrance to the San Juan Capistrano Substation site require maintenance. Photo facing west.
3/14/19	San Juan Capistrano Substation

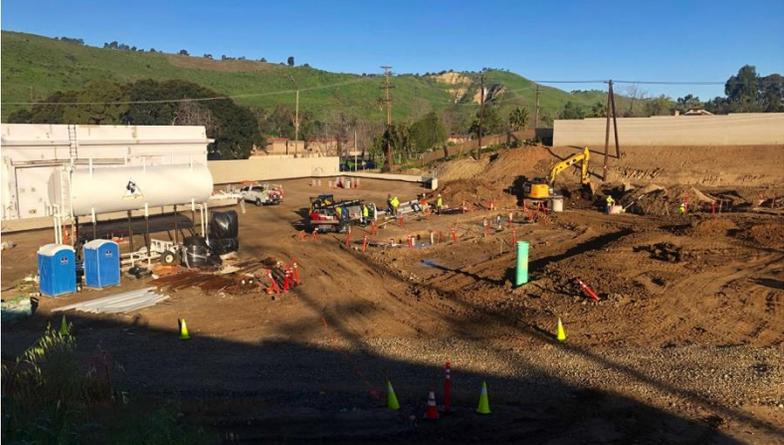
Photo 2 – Overview of the western portion of the San Juan Capistrano Substation site. Photo facing northwest.

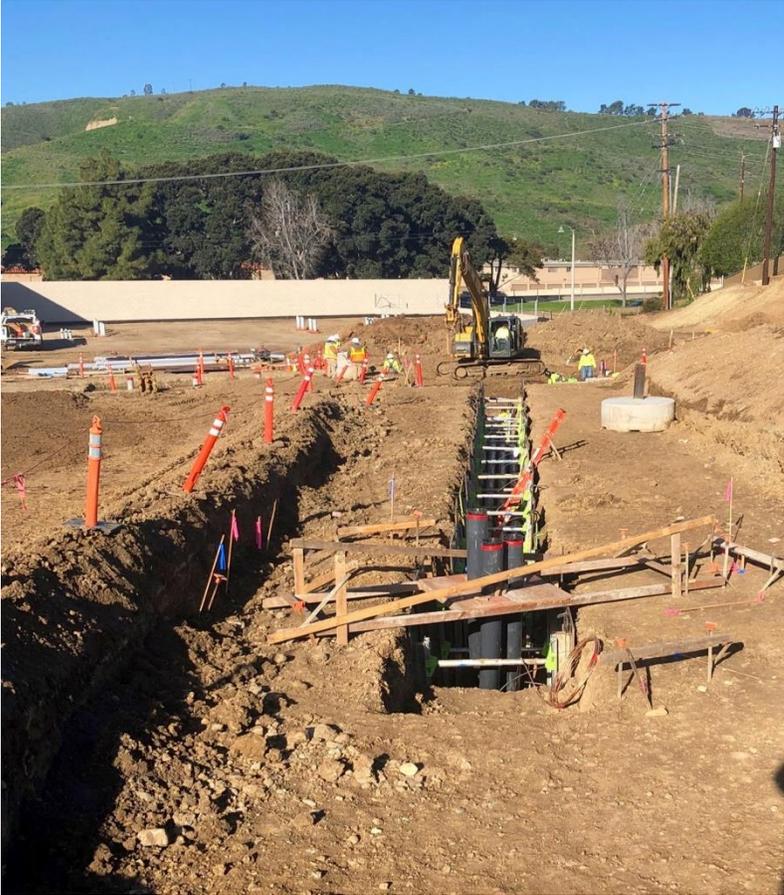
Conduit work was being conducted on the day of my visit, and a concrete/slurry trench will be poured soon after this work is complete (Photo 3). The SDG&E Lead Environmental Coordinator indicated that a new concrete washout station will be set up for pouring concrete into the trench. Several power poles have been relocated to the northern portion of the San Juan Capistrano Substation site (Photo 4).

Photo 3 – Conduit work. Photo facing west
3/14/19	San Juan Capistrano Substation

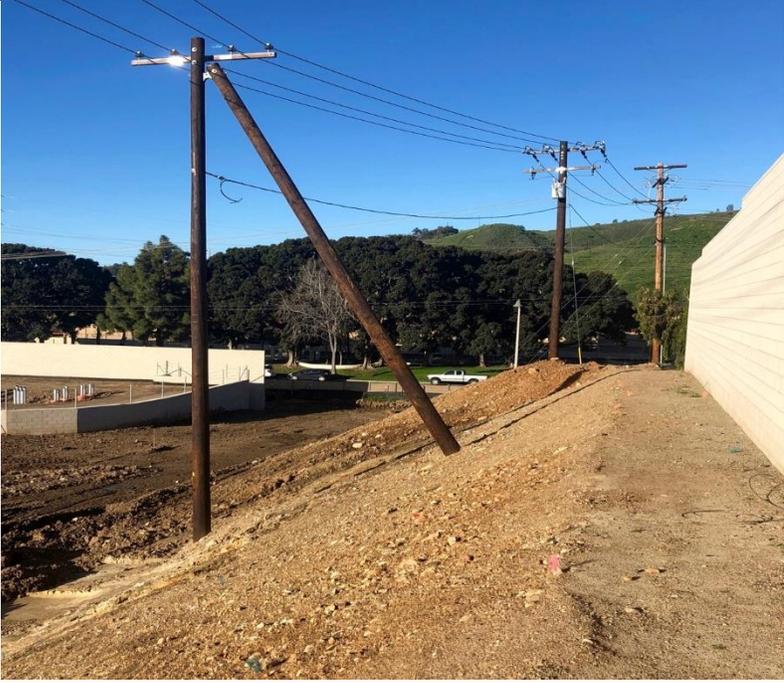
Photo 4 – Slope below the northern boundary wall has been graded and several power poles have been relocated to this area. Photo facing west

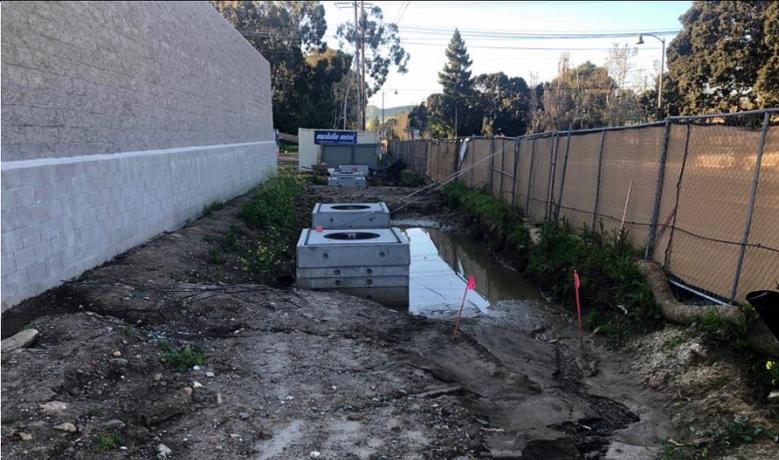
Rainwater runoff from the northern portion of the San Juan Capistrano Substation site appeared to travel toward the western border of the site where a low area is present near two vaults (Photo 5). I noted that water had ponded in this area.

Photo 5 – Stockpiled soil just below the existing 138/12-kV substation and low area near two vaults. Photo facing west.
3/14/19	San Juan Capistrano Substation

Check stormwater best management practices (BMPs) and sediment control.

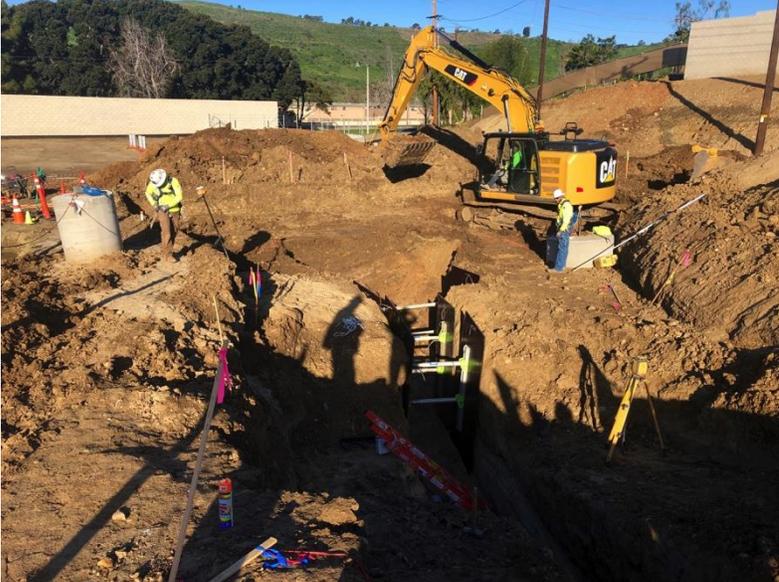
A crew with an excavator was digging a deep hole near the conduit trench and a nearby concrete washout station is sealed and contained (Photo 6). The SDG&E Lead Environmental Coordinator indicated that the conduit trench was still within recompacted soil, and undisturbed soil was not being impacted. If undisturbed soil were to be impacted, Cultural, Paleontological, and Archaeological resource monitors must be present during all ground disturbance. The SDG&E Lead Environmental Coordinator indicated that monitors may be required for final grading below the southern boundary wall because undisturbed soil may be impacted.

Photo 6 – Excavator digging a deep hole near the conduit trench; nearby concrete washout station is sealed and contained. Photo facing west.
3/14/19	San Juan Capistrano Substation

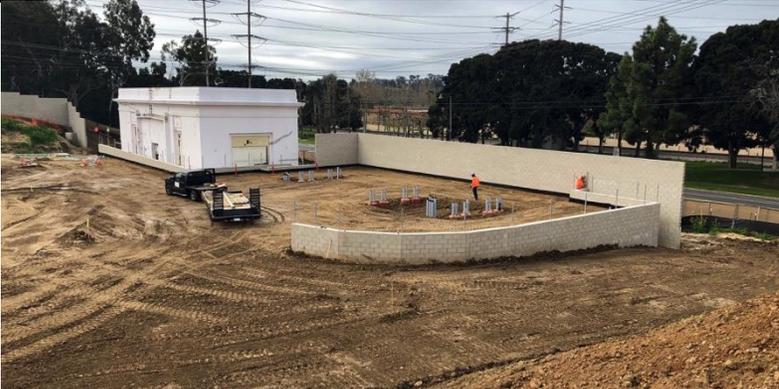
Photo 7 shows the nearly completed western wall adjacent to the former utility building.

Photo 7 – The western wall and former utility building. Photo facing southwest.

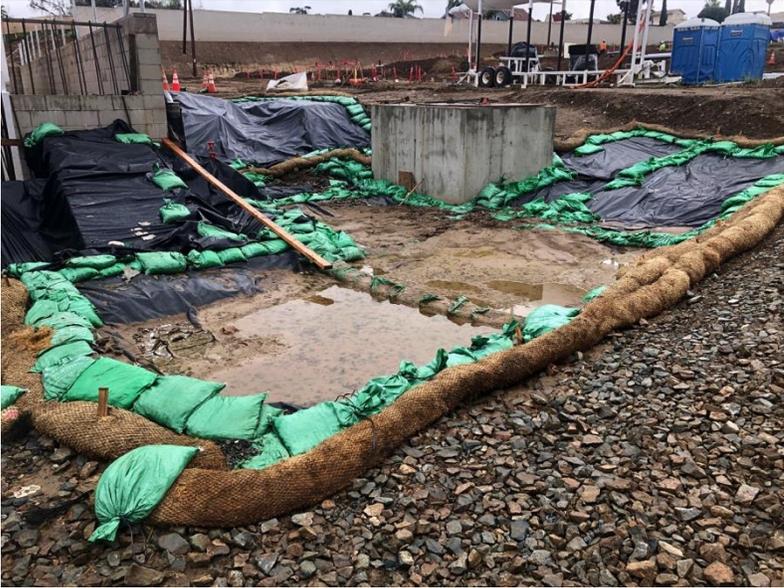
I met with the SDG&E Lead Environmental Coordinator at the main entrance to the San Juan Capistrano Substation site and he stated that some of the best management practices (BMPs) had been repaired or replaced earlier in the week (Photo 1).

Photo 1 – BMPs remain in place near the main entrance to the San Juan Capistrano Substation site. Photo facing north.
3/21/19	San Juan Capistrano Substation

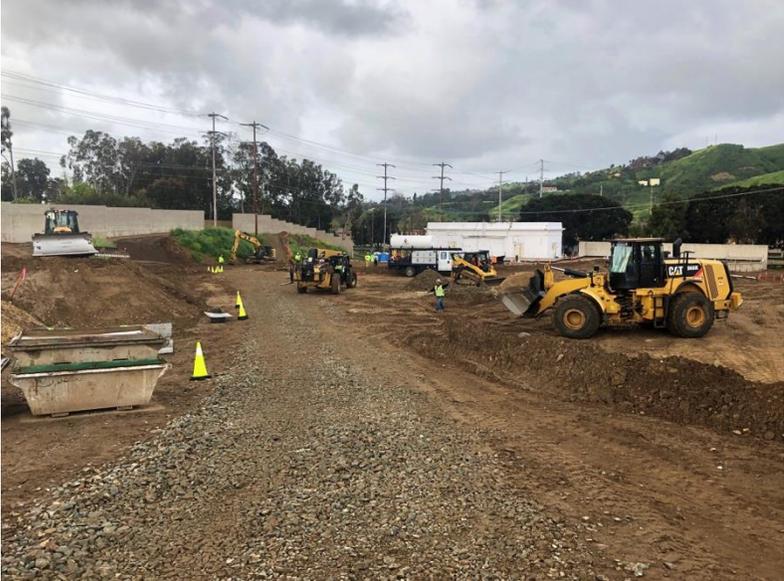
Photo 2 – Equipment moving soil and gravel within the San Juan Capistrano Substation site. Photo facing west.

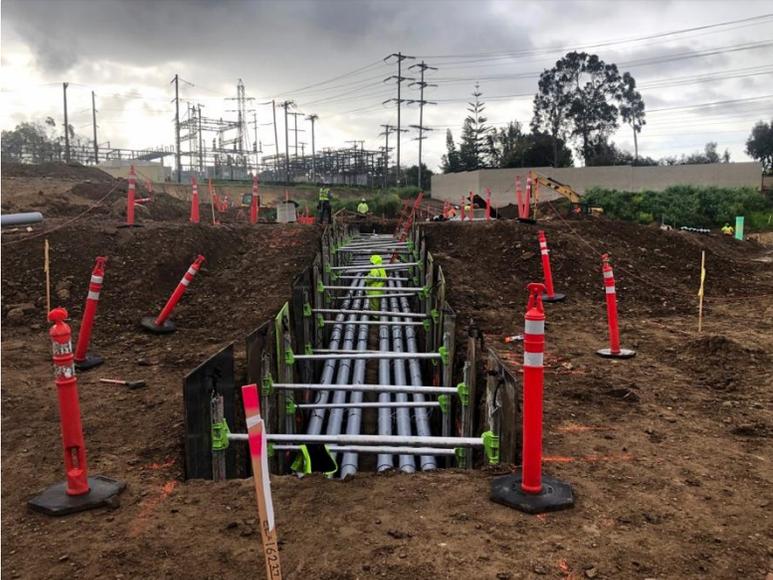
Crews were using a variety of equipment to move soil and gravel within the San Juan Capistrano Substation site (Photo 2). One large conduit trench was open, and the plastic pipe installation was nearly completed (Photo 3). The contractor will add slurry to the conduit trench after installation is complete.

Photo 3 – Conduit work. Photo facing southeast.
3/21/19	San Juan Capistrano Substation

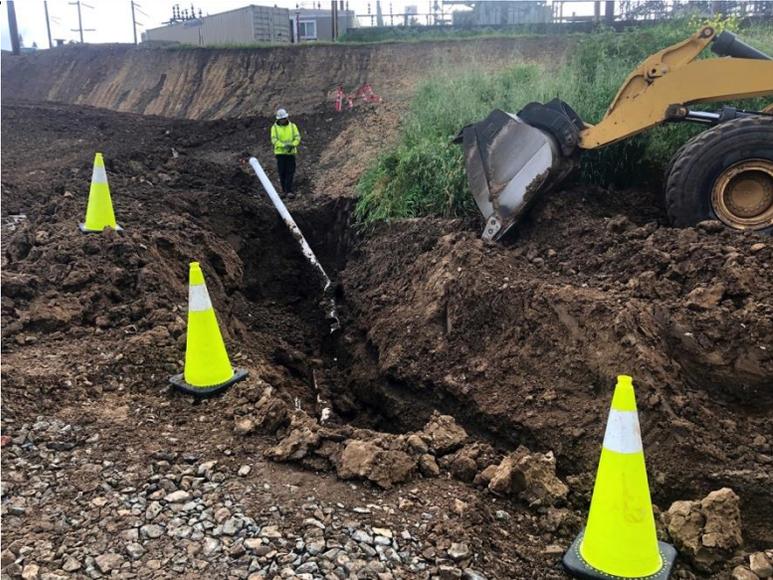
The rock used for road base was being temporarily relocated, and a pipe that had been used to drain the existing 138/12-kilovolt (kV) substation was being removed (Photo 4). The SDG&E Lead Environmental Coordinator said that if another large storm system is forecasted then BMPs would be reinstalled, as needed, to handle rainwater runoff.

Photo 4 – Removal of the stormwater drainpipe coming from the existing 138/12-kV substation. Photo facing east.

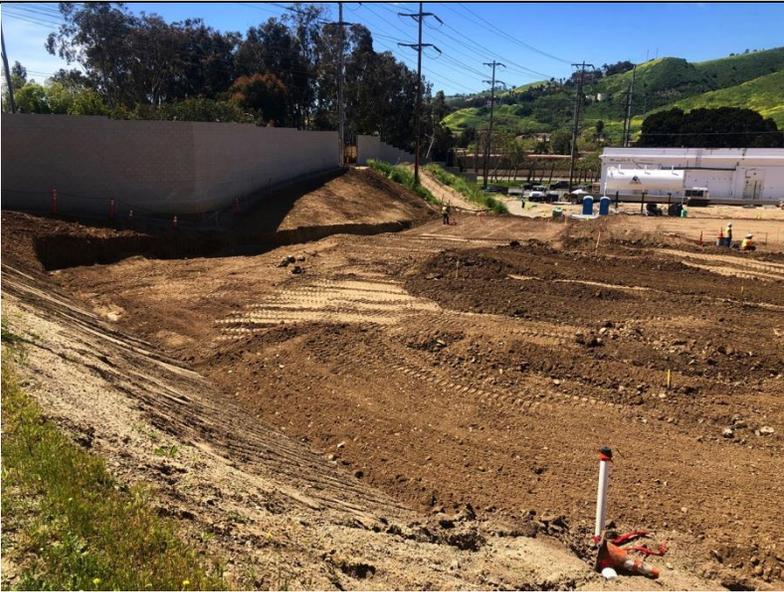
I arrived onsite at 1200. Activities involving soil disturbance were being conducted at the San Juan Capistrano Substation site, including along the southern side of the site where slopes were being laid back (Photo 1). In addition, excavation activities were being completed to open the northern driveway entrance to the San Juan Capistrano Substation site (Photos 4 and 5). There were no dust issues because the soil was fairly damp due to recent rain events.

Photo 1 – Soil disturbance in the southern portion of the San Juan Capistrano Substation site. Photo facing west.
3/27/19	San Juan Capistrano Substation

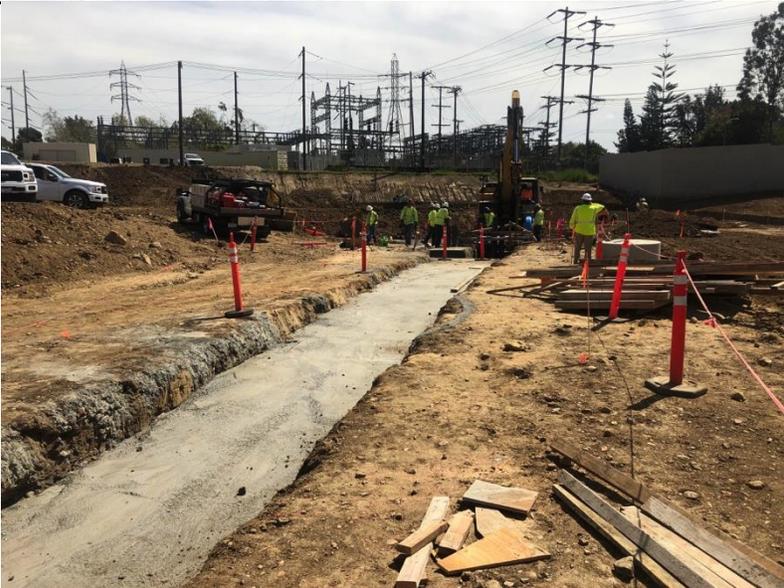
Conduit work was ongoing, and one of the trenches had been filled with slurry (Photo 2). The concrete truck washout station was well-contained (Photo 3).

Photo 2 – Conduit trench work with slurry-filled trench. Photo facing southeast.

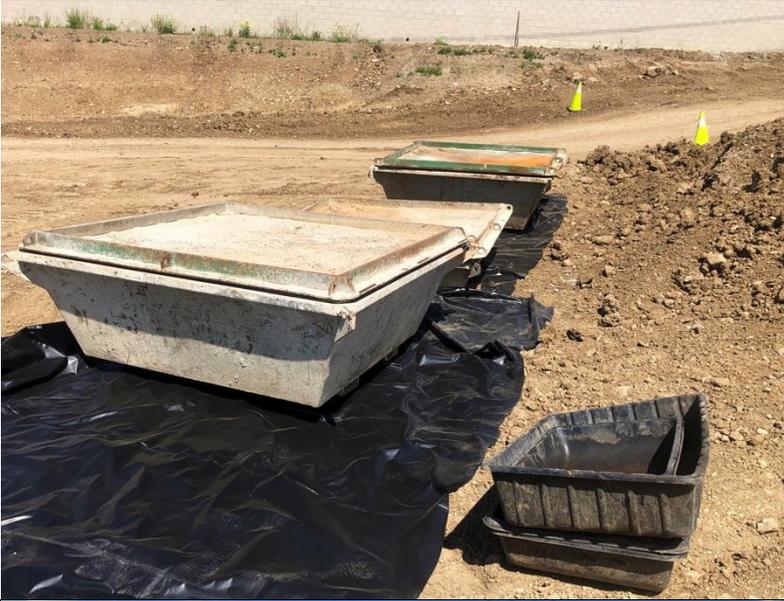
A photograph showing three concrete washout basins. One is in the foreground, another is behind it, and a third is to the right. They are situated on a dirt area with black plastic sheeting underneath. Yellow traffic cones are visible in the background.	Photo 3 – Concrete washout station.
3/27/19	San Juan Capistrano Substation

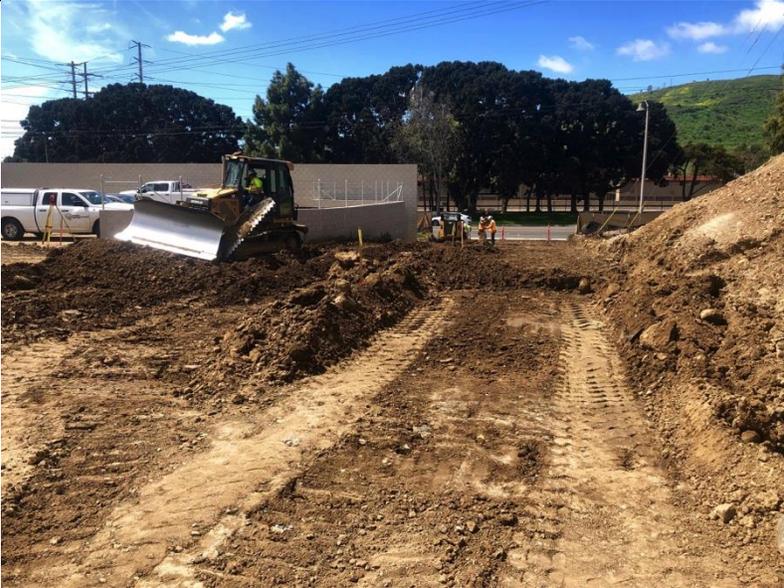
A photograph of an excavation site. A yellow bulldozer is working on a dirt path that leads into a deep, wide trench. In the background, there are trees, a white fence, and a white pickup truck.	Photo 4 – Excavation activities being completed to open up the northern driveway entrance to the San Juan Capistrano Substation site. Photo facing west.
3/27/19	San Juan Capistrano Substation

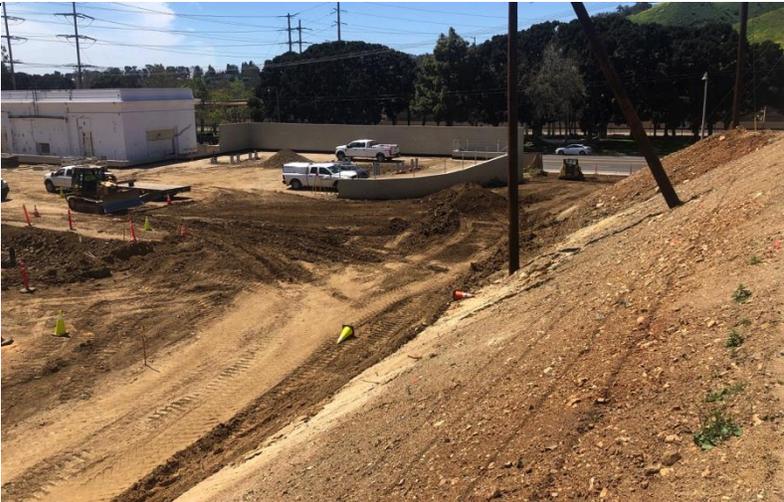
A wide-angle photograph showing an overview of the construction site. A dirt path leads from the foreground into the excavation area. In the background, there is a white building, a white fence, and a white pickup truck. A utility pole is visible on the right side of the frame.	Photo 5 – Overview of work at the northern driveway entrance. Photo facing west.
